## SUCCESS STORY |

# GARNICA GROUP UPGRADED TO BLOCK CENTERING ANALYZER R7 - PEELING WITH AUTOCALIBRATION

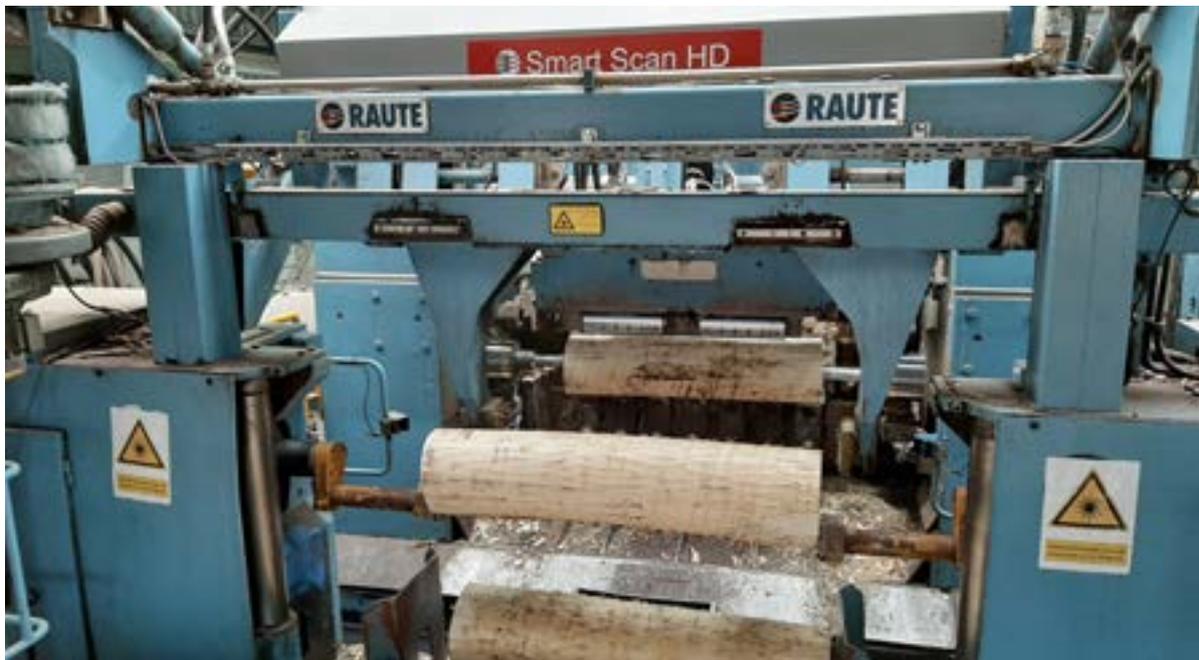
*The Block Centering Analyzer R7 - Peeling block scanner installed in the old Raute PCLH charger.*

Their Valencia de Don Juan mill was the first Garnica mill to install a Raute peeling line, back in 2003. This included a Raute PCLH 800x1400 XY-charger with SLS 6000-single point laser, which served the mill well for many years. However, by the beginning of 2019, the 16 year-old block centering technology clearly needed to be modernized. The laser sensors and control PC were no longer available, and the system needed to be calibrated several times a month, which required too much maintenance time.

Garnica ordered the Block Centering Analyzer R7 - Peeling with autocalibration from Raute in January 2019. The system was delivered and installed in May 2019 during a scheduled production stop over a long weekend. With the help of Raute specialists during the start-up, the line was running at full capacity within a few days.

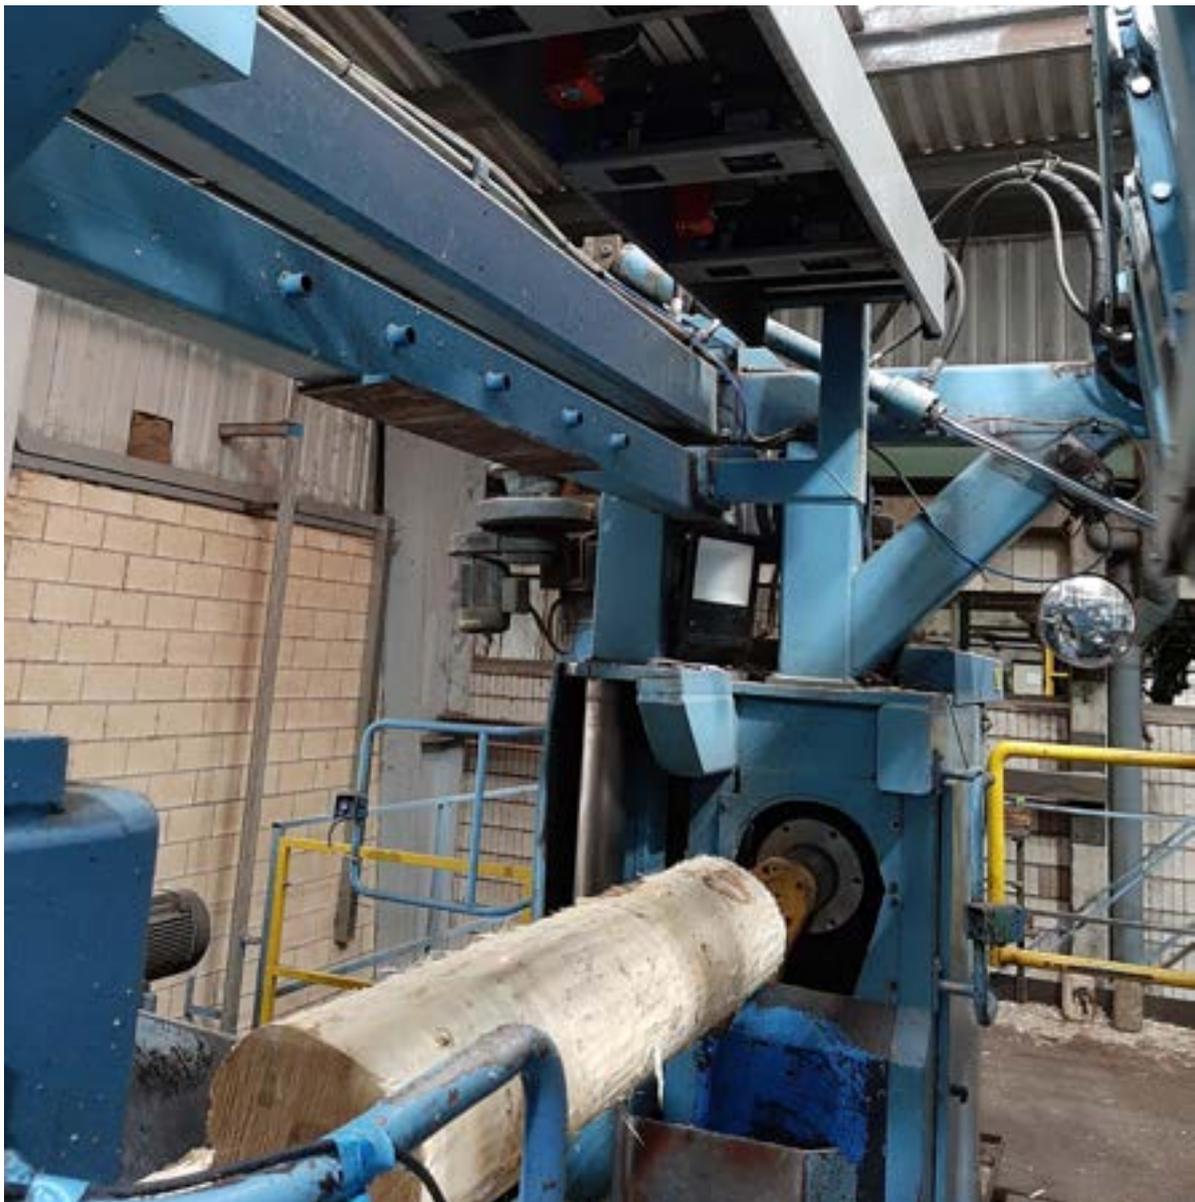
*Block Centering Analyzer R7 - Peeling lasers ensure centering accuracy.*

The mill is also particularly pleased with the autocalibration system because they don't have to worry about centering offset adjustments or sensor calibration. In fact, they have only spent a few maintenance hours in the last 6 months at the XY charger. The system automatically calibrates itself, measuring and comparing continuously to correct the axis home position. The autocalibration system also provides data which can be used to track performance and predict mechanical failure.
